#### 4.3.2.6 Unit Type CP.3.X 2700-2800 Area

This one-story three-bedroom duplex was built in 1966. It is of standard wood frame construction with a concrete slab on grade. Unit has an attached one car carport.

#### 4.3.2.7 Unit Type CP.3.Z 2700-2800 Area

This one-story, three-bedroom single-family unit with a detached one-car garage was built in 1959. It is of standard wood frame construction with a concrete slab on grade.

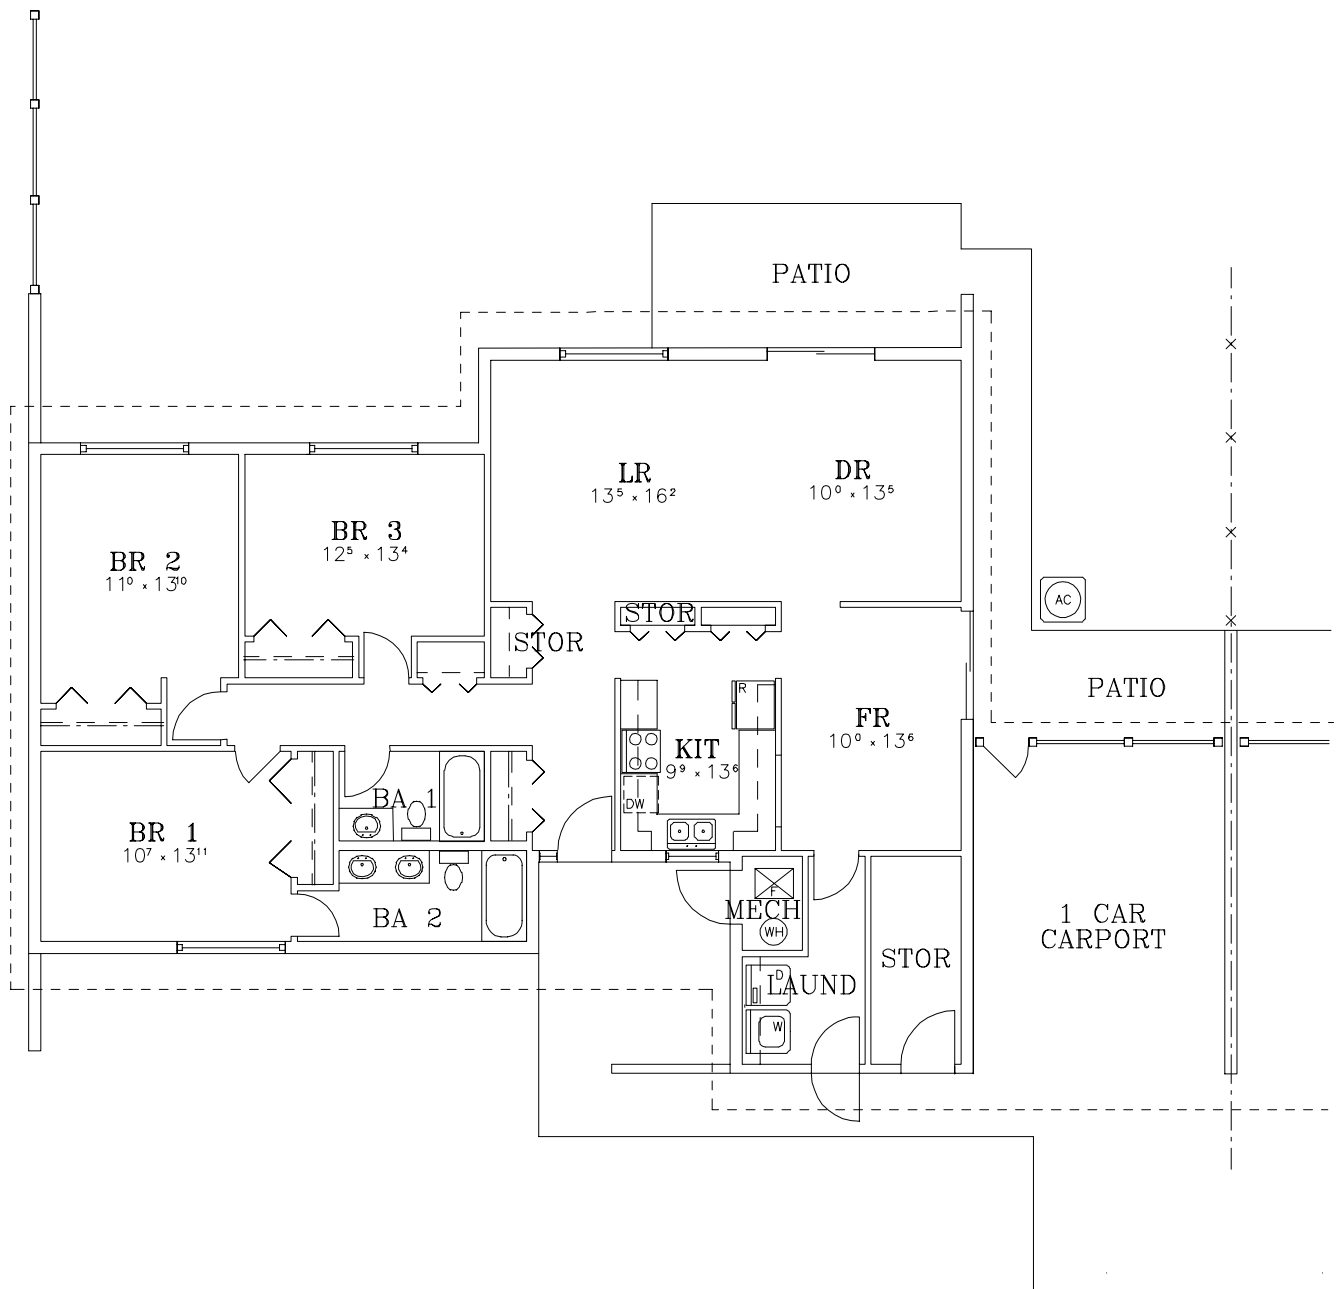
**EXISTING**

**Unit Type CP.3.W**  
**3 BR FGO/CGO**

GROSS SF: 1671  
NET SF: 1400

- Overall Floor Plan: reconfigure exterior storage to provide interior storage; provide an addition for direct access from garage to the unit per proposed plan.
- Architectural Aesthetics: eliminate brick screen wall at front entry; add window to master bathroom and add front porch railing to improve aesthetics and open/define unit entry.

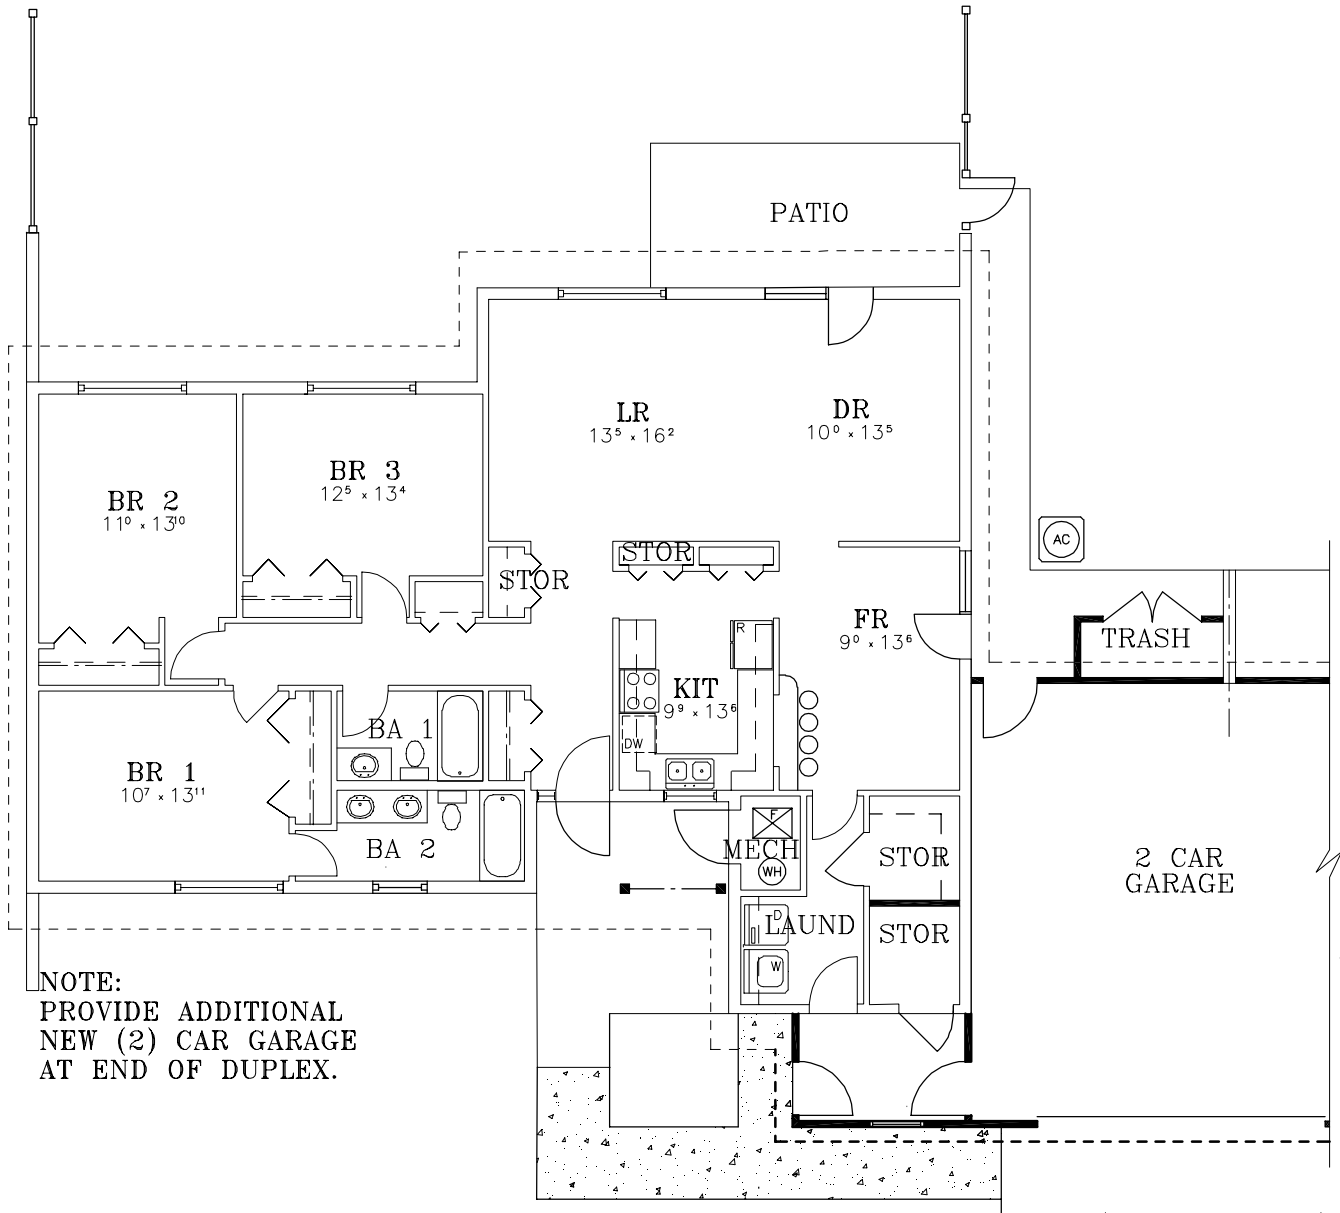
**PROPOSED**

**Unit Type CP.3.W**  
**3 BR FGO/CGO**

GROSS SF: 1671  
NET SF: 1413

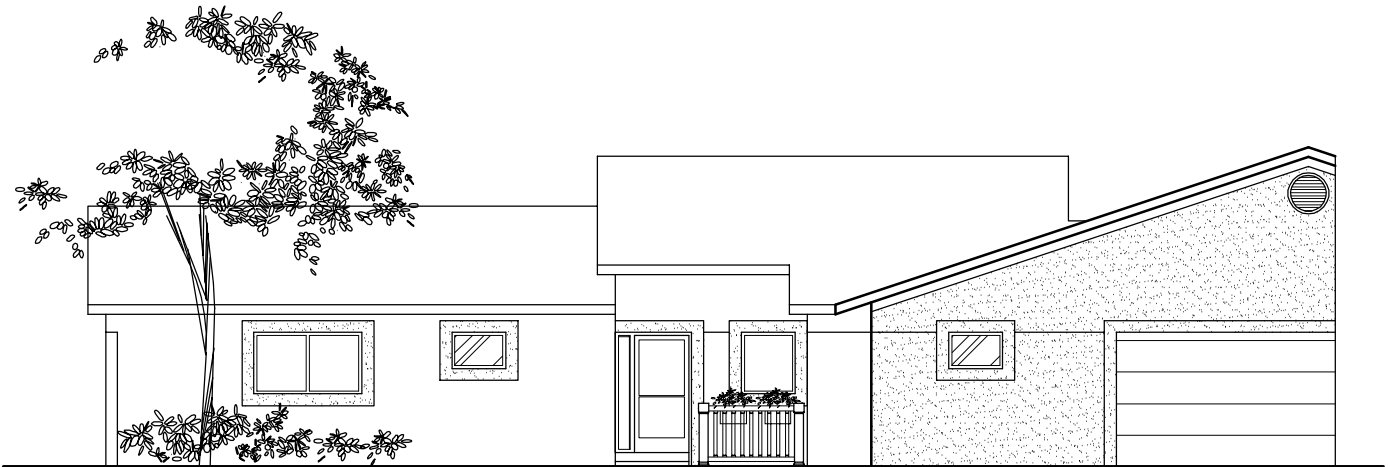
## FRONT ELEVATION

**Unit Type CP.3.W**  
**3 BR FGO/CGO**

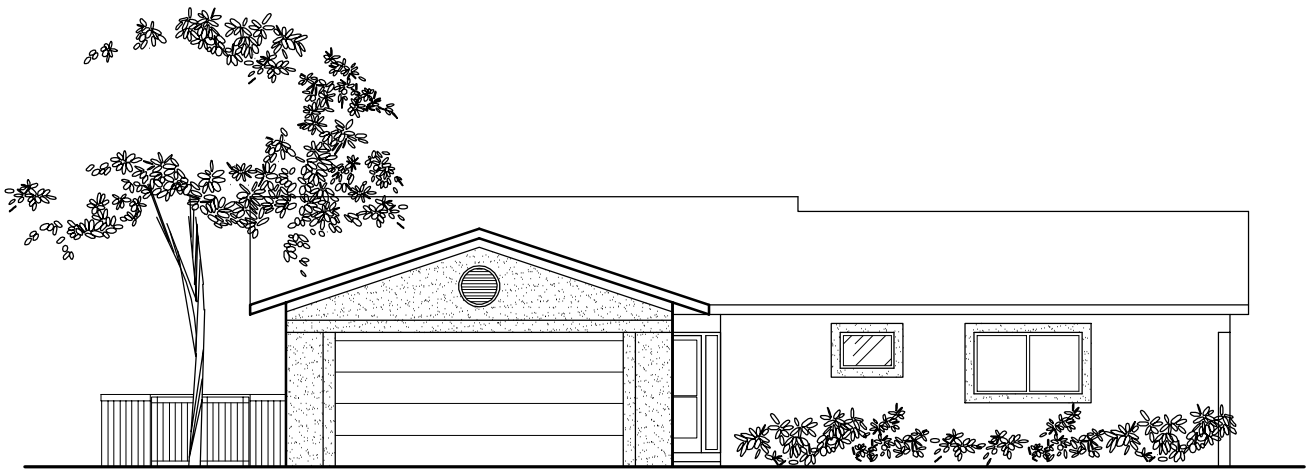
## FRONT ELEVATION

**Unit Type CP.3.X**  
**3 BR CGO**

- Kitchen: add counter between Kitchen and Family Room for secondary eating area.
- Covered Parking: provide two car garage with new fiberglass insulated garage door with opener per proposed plan.
- Overall Floor Plan: reconfigure excess exterior storage to provide additional interior storage per proposed plan.
- Architectural Aesthetics: provide new garage to improve character; add a window to master bathroom and window shutters to improve front elevation aesthetics and natural light in bathroom.

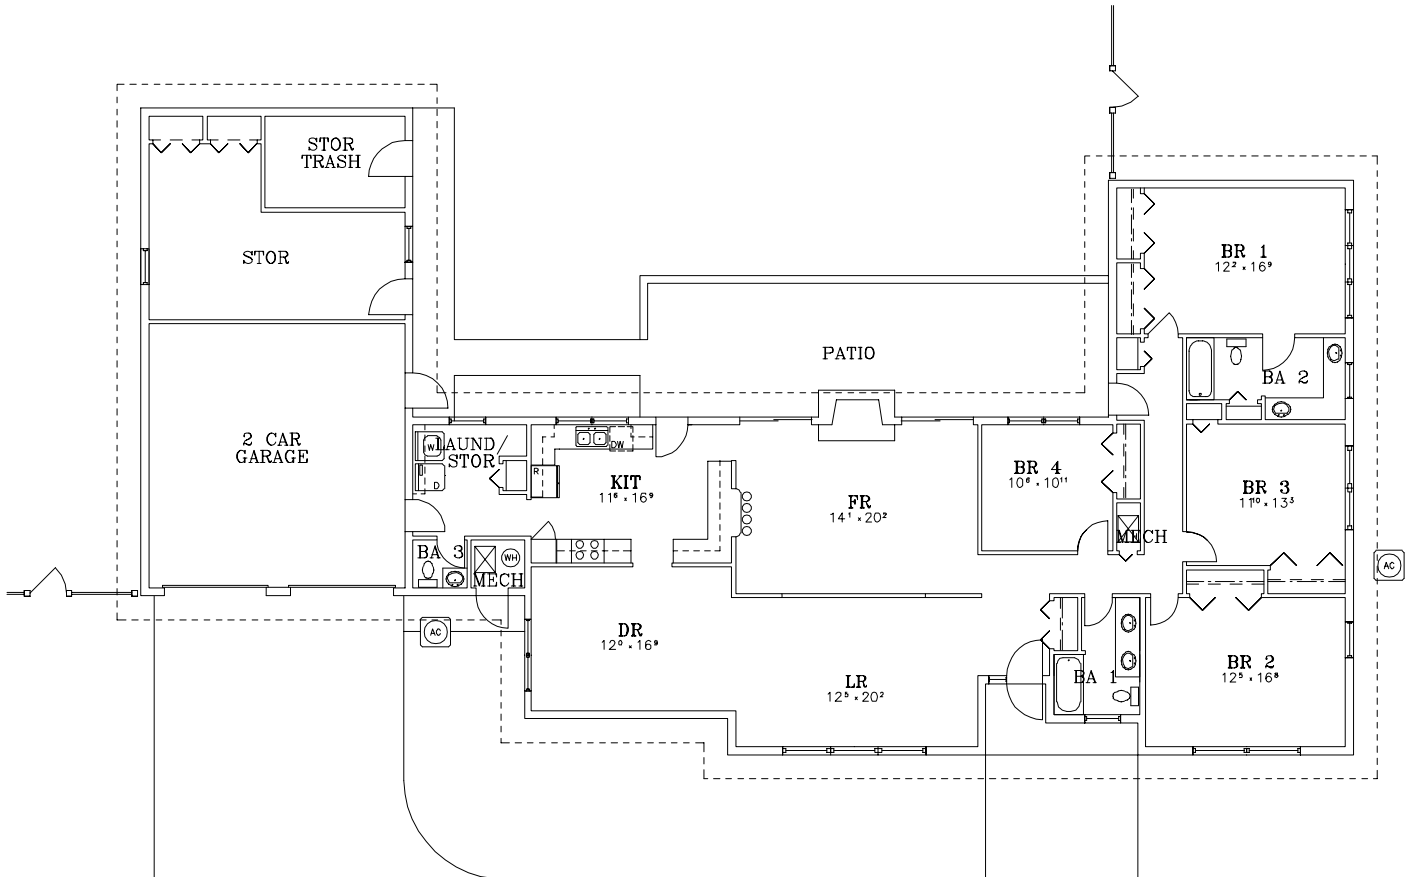
**EXISTING**

**Unit Type CP.4.S**  
**4 BR SOQ**

GROSS SF: 2396  
NET SF: 2125

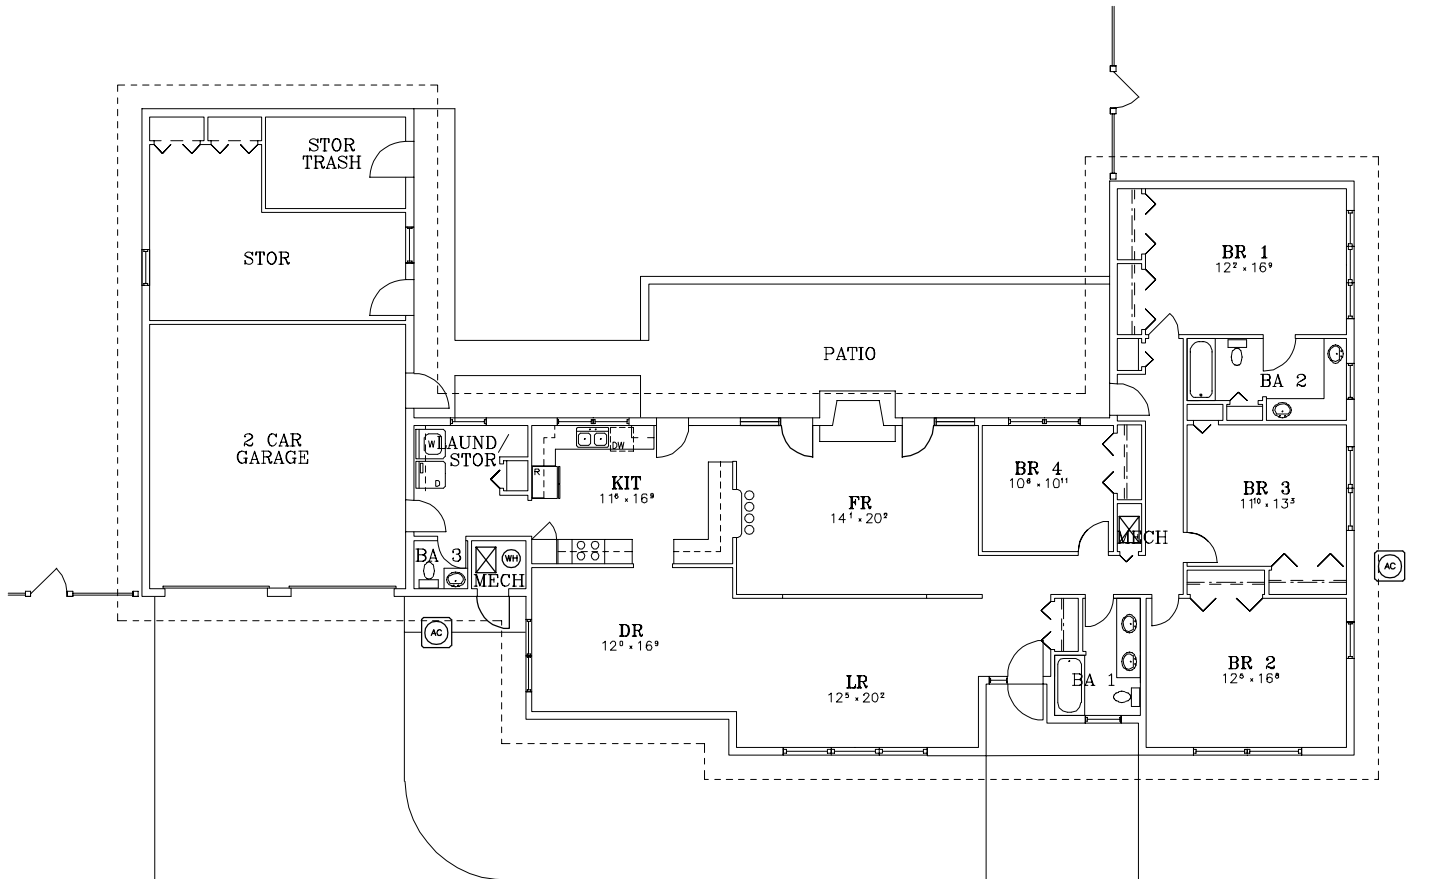
**Unit Type CP.4.S**  
**4 BR SOQ**

GROSS SF: 2396  
 NET SF: 2125

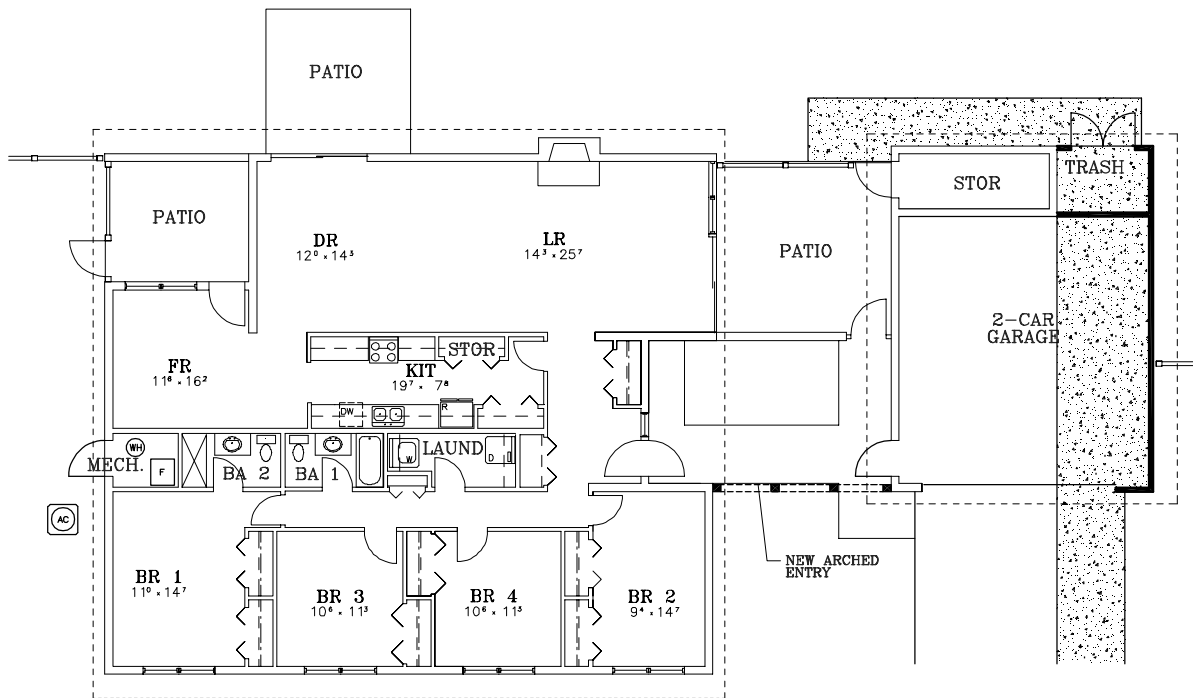
**EXISTING**

**Unit Type CP.4.T**  
**4 BR SOQ/FGO**

GROSS SF: 2011  
 NET SF: 1772

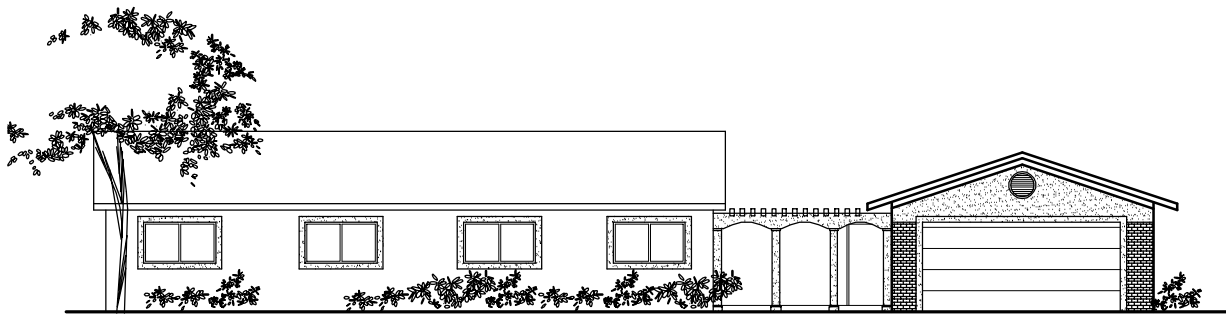
FRONT ELEVATION

**PROPOSED**

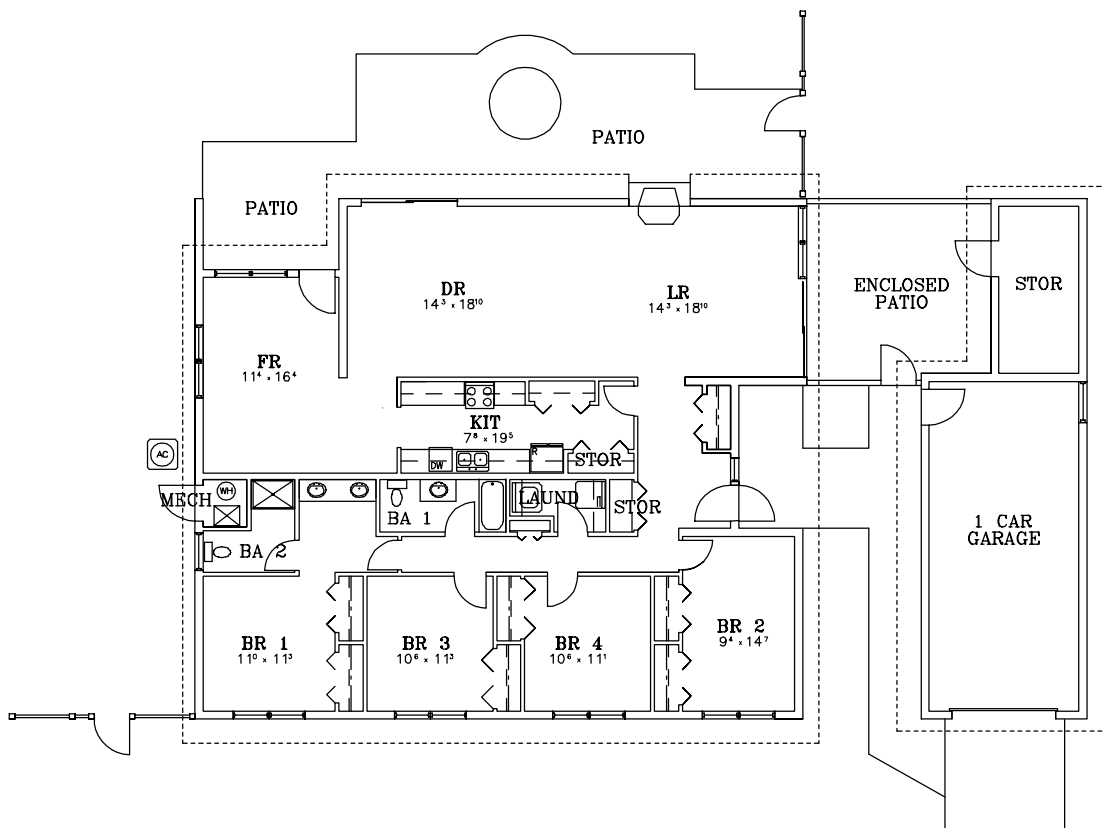
**EXISTING**

**Unit Type CP.4.U**  
**4 BR SOQ**

GROSS SF: 2067  
NET SF: 1864

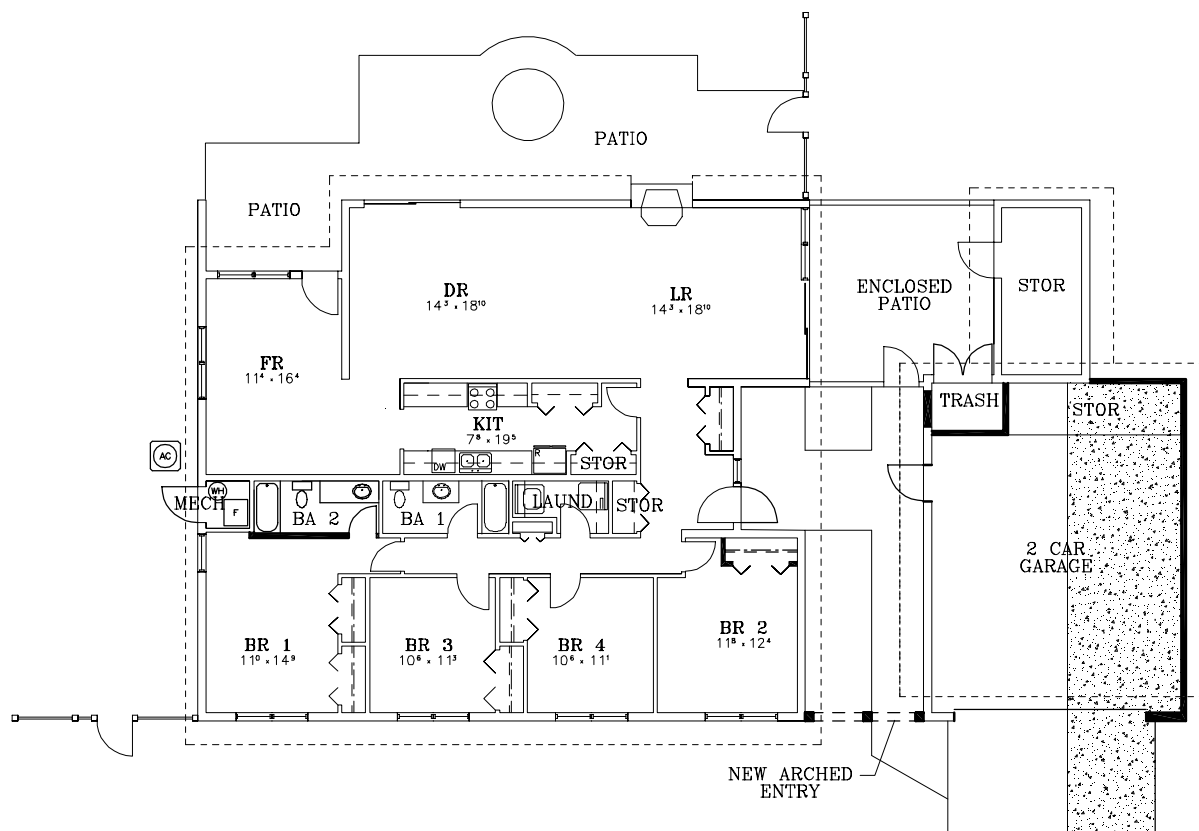
**PROPOSED**

**Unit Type CP.4.U**  
**4 BR SOQ**

GROSS SF: 2067  
 NET SF: 1864

- Bedroom 2: relocate closet to satisfy minimal dimension requirements.
- Covered Parking: expand existing one car garage to two car garage and expand concrete driveway per proposed plan.
- Architectural Aesthetics: build-out stucco around windows and provide an arched entry to improve aesthetics.
